CALVER MILL

Lynn Willies

Abstract: The site was a smelting mill from at least 1616 to 1773, and in the mid- or late 19th century was rebuilt for cornmilling, ceasing work probably before 1914. Water from two mine soughs fed the cornmill dam. Rebuilding for domestic use in mid-1987 has destroyed many features but gave opportunity for a rapid survey.

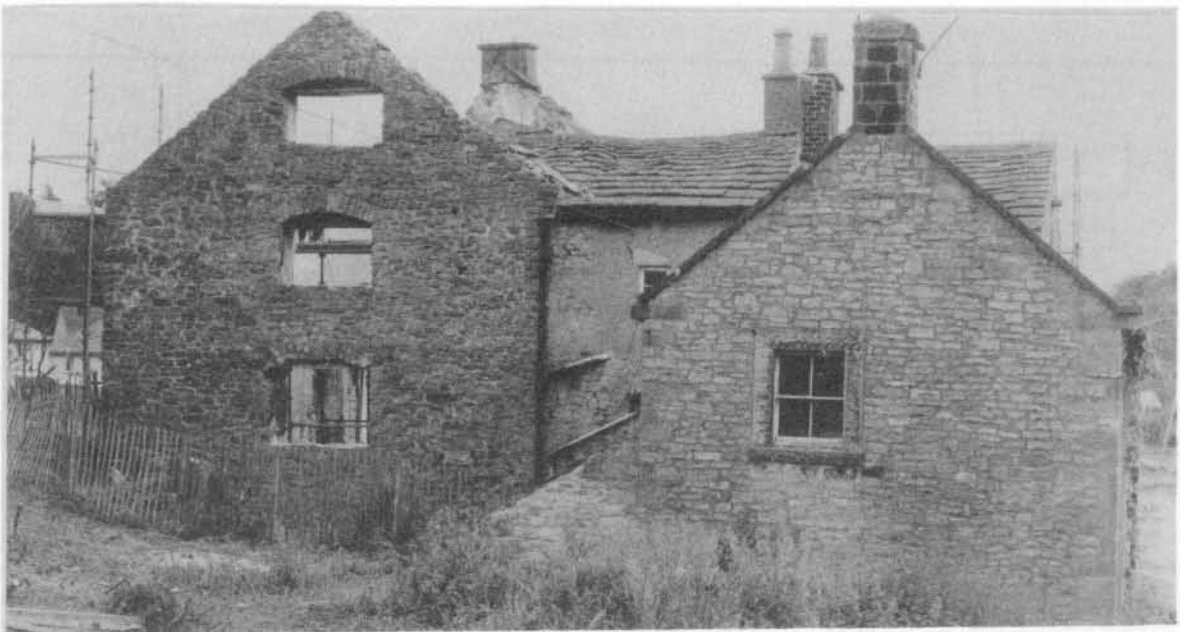
Calver Mill - the mill building is on the left, with the wheelpit protected by the chestnut paling. The centre building is later, linking the mill to the possibly older building, right.

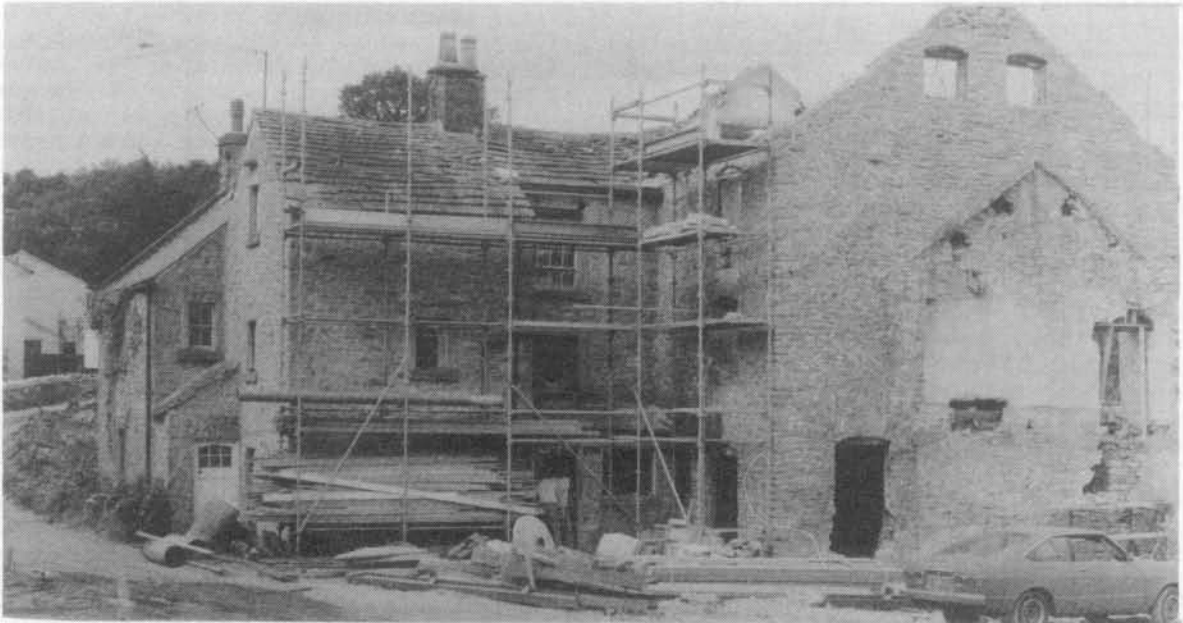
View from the opposing side, the mill building is to the right, following demolition of a later extension.

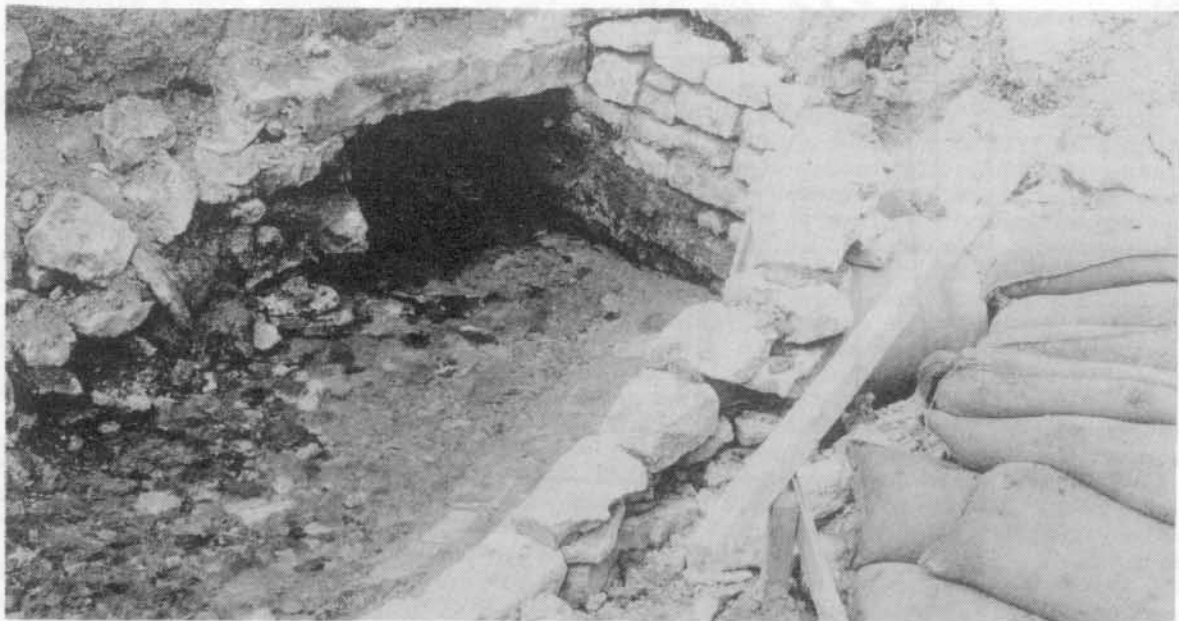
Unroofed section of a sough, which passes under the southerly, lower and older pond. The water in it flows from Brightside Sough, though its tail is today higher up the valley.

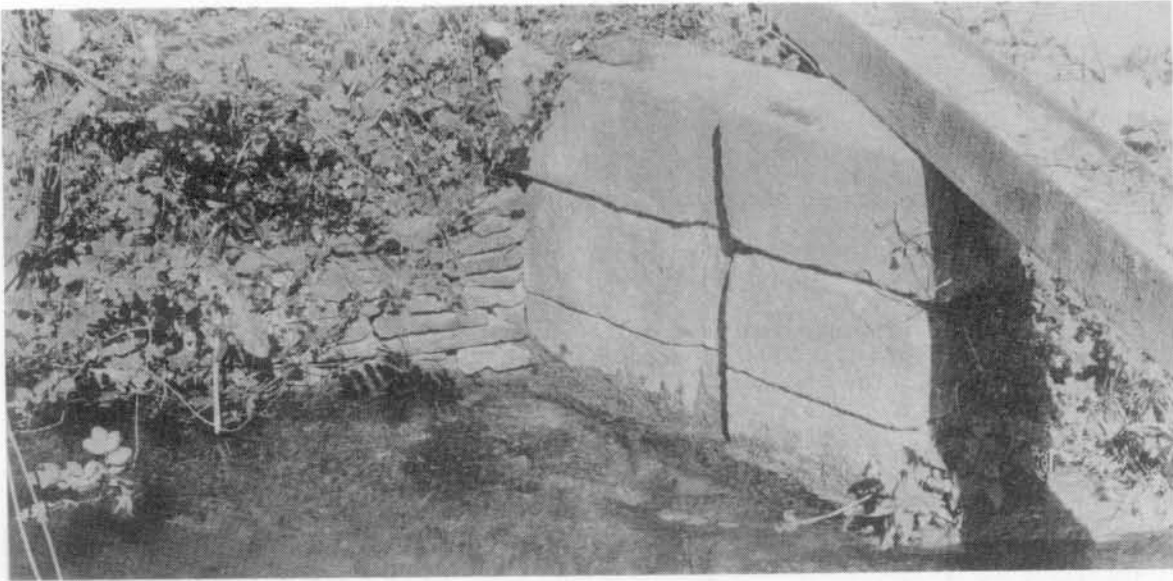
The penstock and headrace is incomplete: any box and sluice arrangements have gone (but

two opposed holes above the wheel rim may relate to some mechanism for this). Gritstone slabs line the channel beyond the immediate head, linked by a short stretch of rubble limestone to a wider section. This last has massive gritstone blocks with a slot for timbers or some form of sluice, and leads out directly to the dam. A rectangular trough formed of glazed earthenware leads any overflow or seepage from this section of dam to the top of the wheelpit.

The penstock of the mill, with board-slots cut into gritstone blocks. Water emerges a few metres away up from a shaft on Calver Mill Sough, which has apparently been blocked off. After passing through the wheelpit, it rejoins the sough, to emerge near the river.

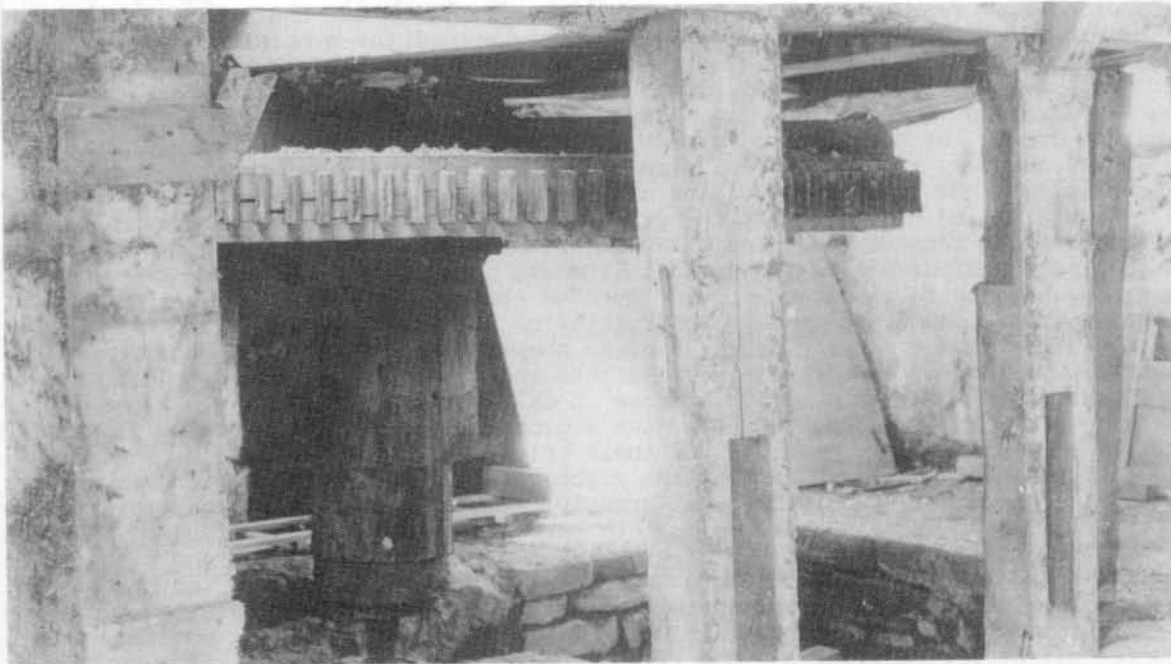
The vertical shaft has a central square section of 0.70 m across to receive the spokes of the wooden gears, but is rounded above and below. The square section has bolts to maintain strength and there is an iron hoop at the rounded base. The bearing is formed by a conical insert, running in the bearing block.

The large gear wheel is made of timber, formed by four heavy spokes at right angles enclosing the vertical shaft, with a rim of eight heavy wood felloes jointed to each other and reinforced by an iron plate. The whole is 3.3 metres (11 feet) across, and has 144 wooden teeth inserted into sockets on the inside rim by an iron pin. The gritstone lintel over the wheel opening is cut back to allow it to fit. A smaller spur wheel was probably also attached just below to receive the drive from the water wheel via a pinion: this has disappeared, perhaps suggesting it was of iron construction. The large gritstone block adjacent has been cut back probably to allow this to function. Like the larger wheel above, it would have been secured and positioned by wedges and by a block on each face held by coach bolts.

The main shaft of the mill passed up through the first floor to power the stones. Most of the machinery had gone, but the gear wheel with its wooden teeth shown here has been retained as a feature in the newly converted house.

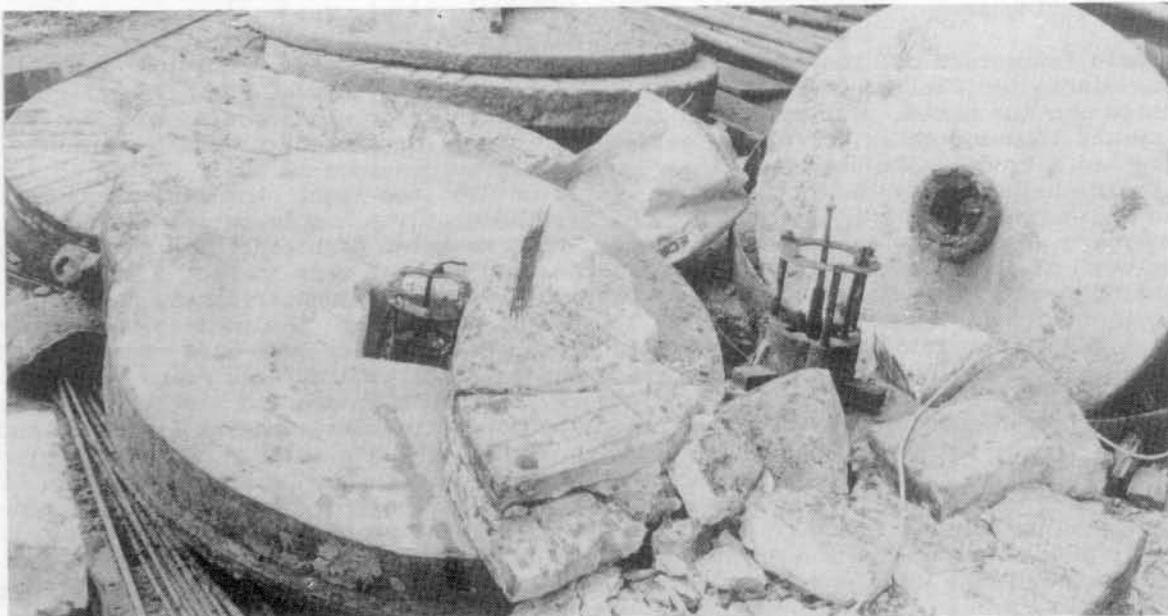
The sets of millstones all had different sizes, and four different driving arrangements for the upper stones. Two of the peripheral sets were of the french burr-type, with a similar cage-like drive system secured with iron and wood wedges and bolted tapers. The other two were gritstone, as was also the third smaller set. It seems likely the gritstone wheels will form a feature in the refurbished premises - unfortunately one of the burr-stones had already been broken up, another partially so. They were originally thought of as "concrete" and were unappreciated by the builders. One burr-stone had cavities infilled by lead! Detail is shown in the photographs and descriptions.

Millstones - at rear the traditional type, with in the foreground a composite burr-type wheel, probably from France, using a siliceous rock bonded by plaster and bound by iron straps.
